**Customer: Semiconductor Manufacturing Plant**

**System/Product: Crack repair on a FRP tank nozzle**

A customer at a semiconductor manufacturing plant needed to have a flange repaired in a short period of time. The crack is assumed to happen when the mechanical contractor over tightens the bolts on the flange. The nozzle was not put in service, but was noticed and wanted to be fixed prior to putting the tank back in service.

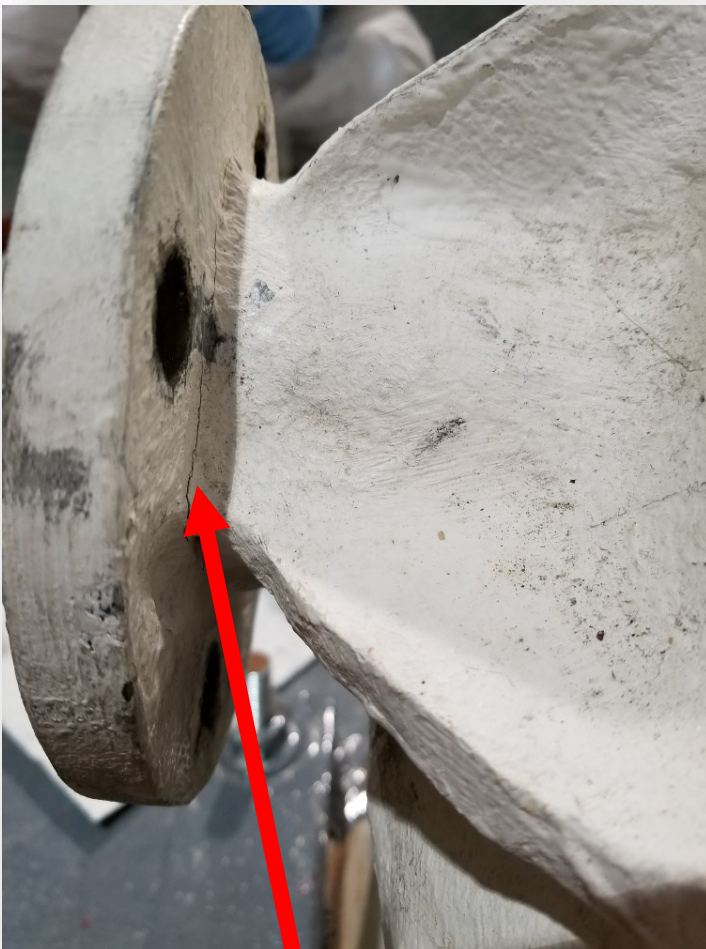
Small hair line crack at the flange to pipe transition.
